# Rips, Strips and Broken Tips: Part III: Treating the Untreatable – A Case Report

# CASE REPORT

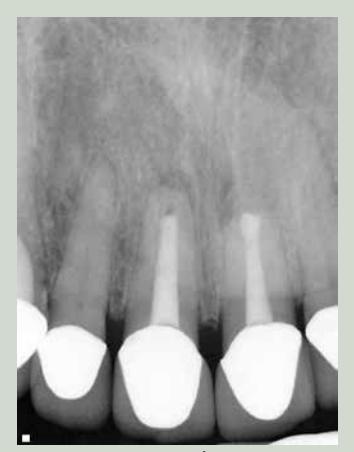
FIGURE 11-apical plug radiograph.

A barrier of synthetic collagen membrane (NeoCote) was placed in the canal of each tooth, and pushed to the working length with obturation pluggers. Once this soft "stop" was created, Mineral Trioxide Aggregate (MT Angelis, Clinical Research Dental) was mixed, loaded into a Dovgan carrier (Clinical Research Dental) and inserted into the canal. The MTA was inserted and condensed until a 5mm apical plug was created.

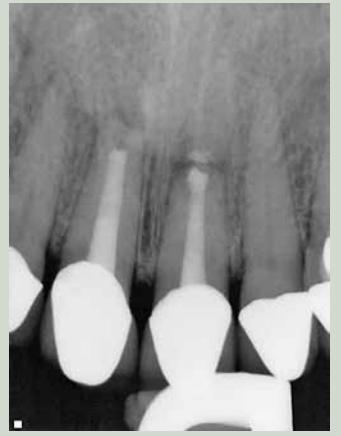
FIGURE 12-immediate post-op radiograph.

checked, the canals were backfilled with sealer and thermoplastic gutta percha in the usual fashion. Access was closed, and the patient was referred back to his family dentist for new core restorations.
